LABORATORY INVESTIGATION OF SCOUR AROUND BRIDGE PIERS

**MRD HYDRAULIC LABORATORY SERIES
REPORT NO. 14**

**MEAD HYDRAULIC LABORATORY
MEAD, NEBRASKA**

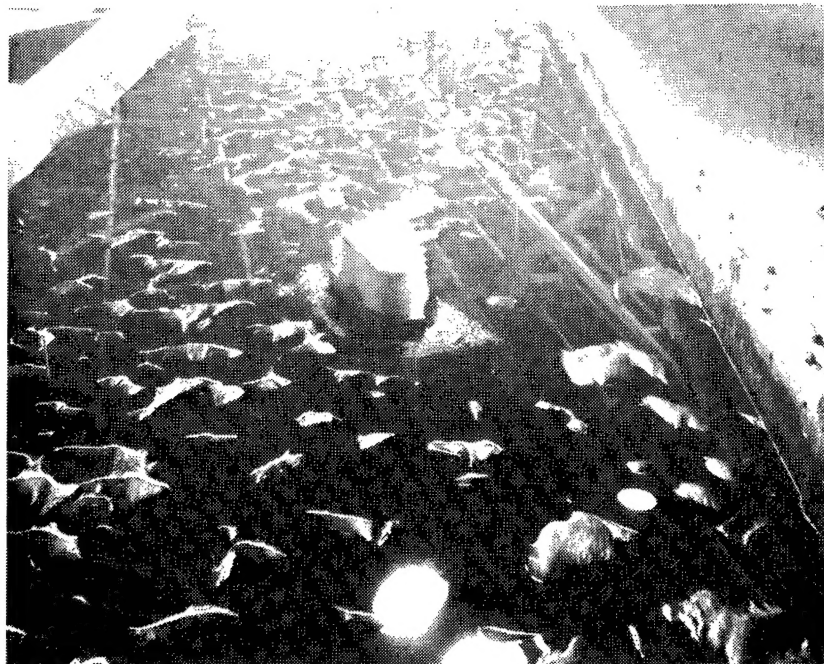
Photo 4. Run 23 looking downstream showing bed configuration at end of run. Bed armor placed at elevation 1.1 or 0.1 ft. below bed level. Note large bar behind pier and exposed stone.
